Applies To: **1998–02 Accord** – ALL
1998–05 Civic – ALL
1999–04 Odyssey – ALL
1997–01 Prelude – ALL
2000–09 S2000 – ALL

March 17, 2009

Deformed Windshield Molding

(Supersedes 00-064, dated November 13, 2007, to update the information marked by the black bars)

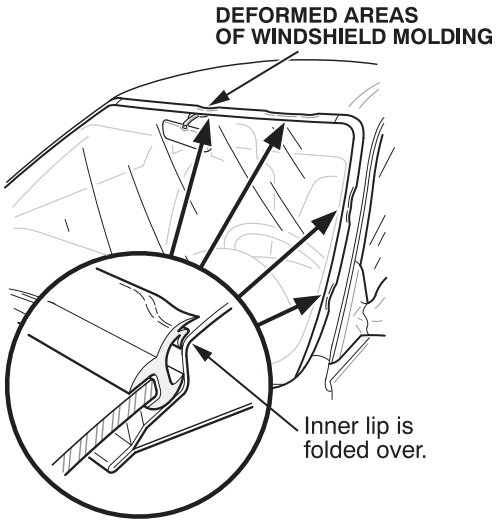
Pull up the outer edge of the windshield molding. Check if the inner lip is folded over anywhere.

- If the inner lip is folded over, go to REPAIR PROCEDURE.
- If the inner lip is not folded, disregard this bulletin, and look for other possible causes.
